Disruption to Transportation Systems caused by Abandoned Mine Workings

Colin J F P Jones
University of Newcastle UK

Interstate Technical Group on Abandoned Underground Mines

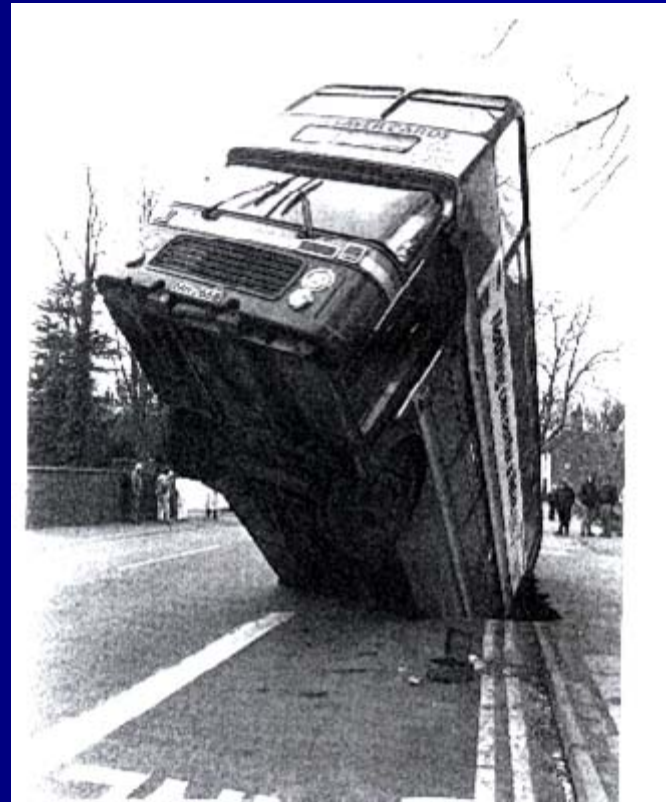
Collapse of old workings
Norwich 1988

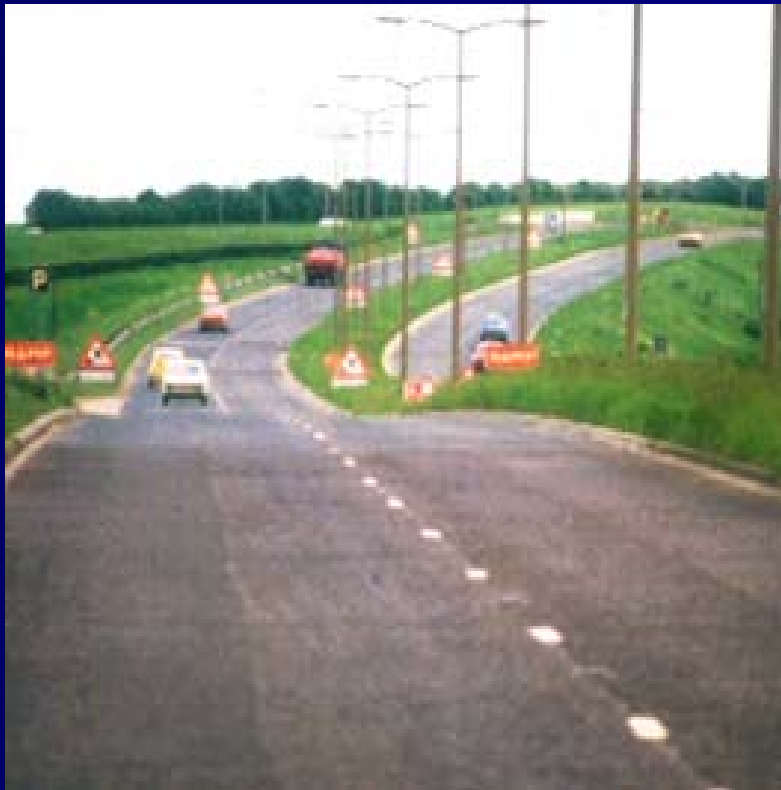
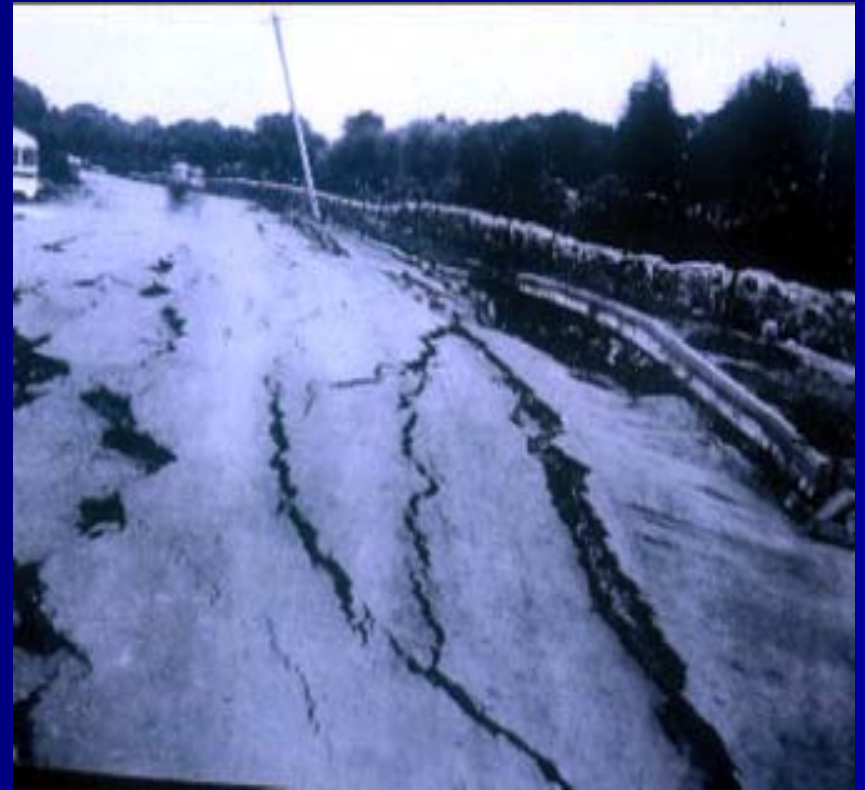
Long wall workings Yorkshire 1980s

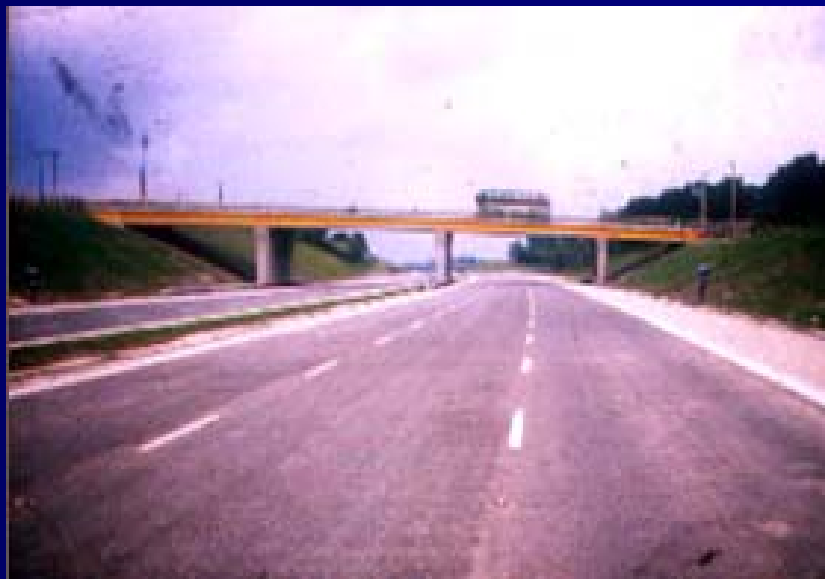
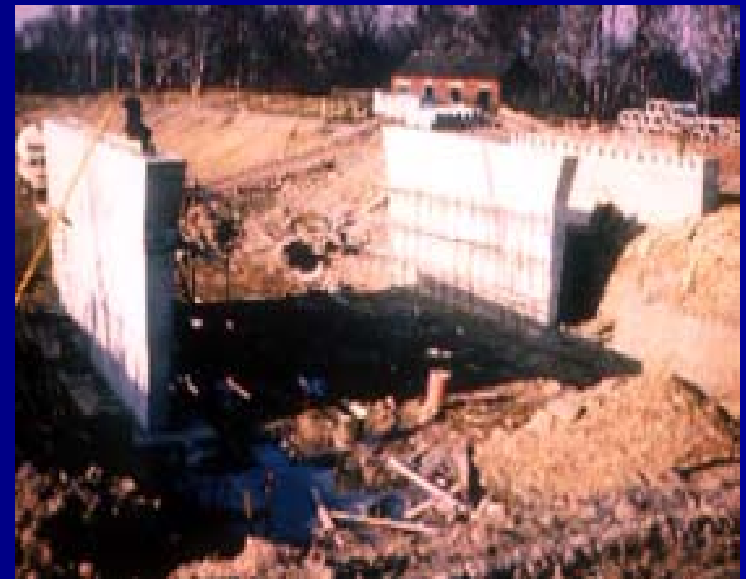
Bridges subjected to 11 components of movement

Dual 3 lane bridge:

- Differential settlement of 600mm
- Change in span length of up to 300mm
- Twist of deck of 1 in 20

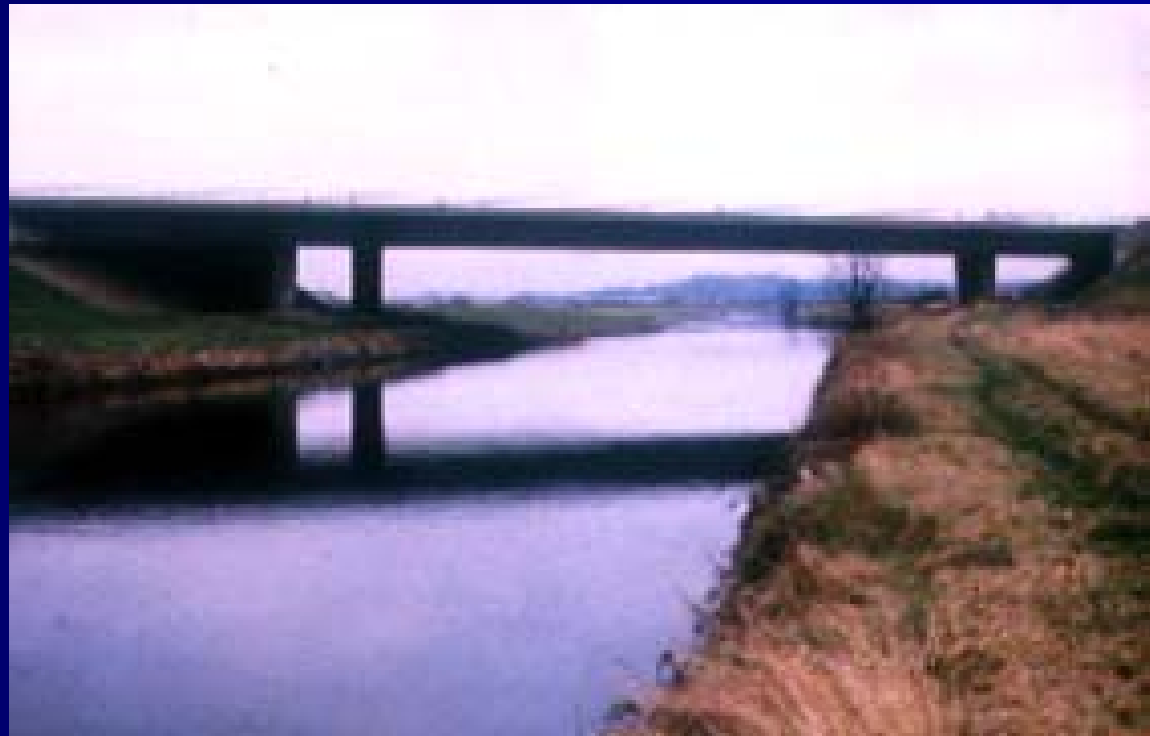
3D statically determinate structures
(supported on 3 bearings)

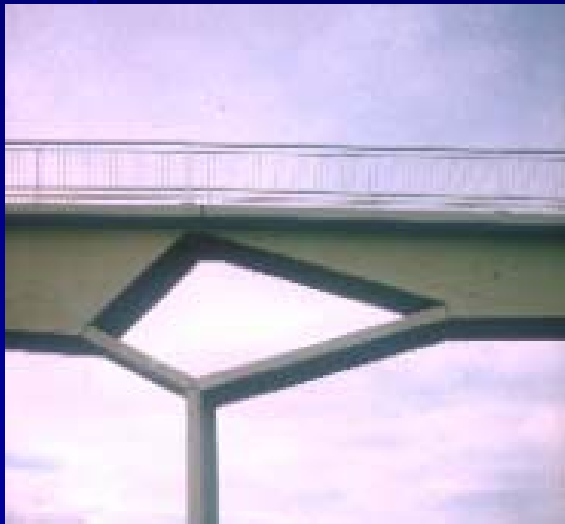
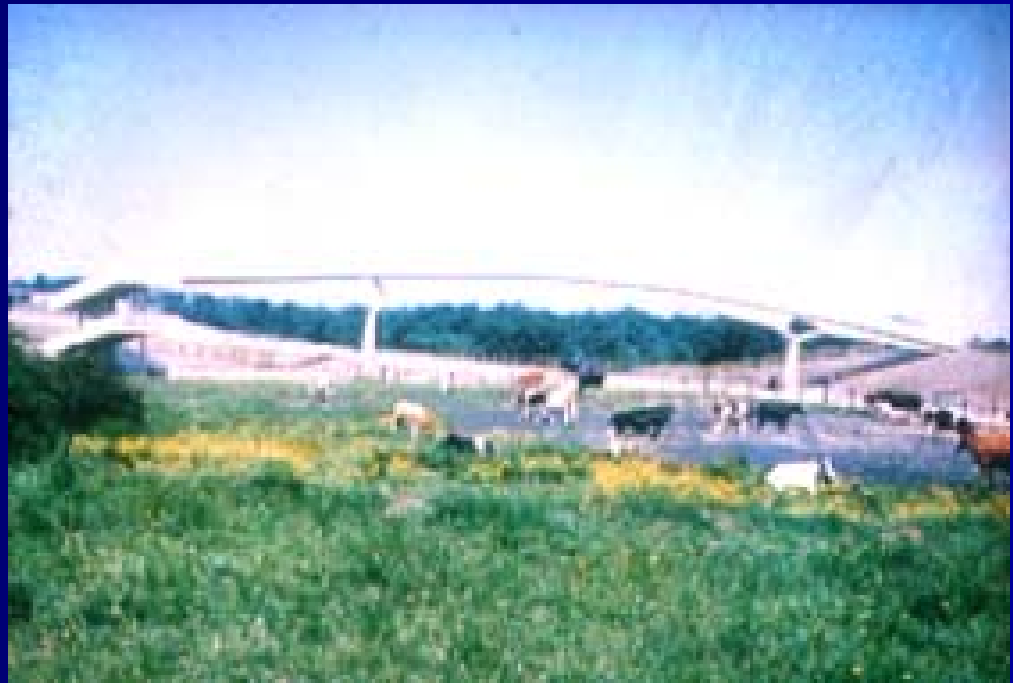
Wichert truss foot bridge using concrete bearings

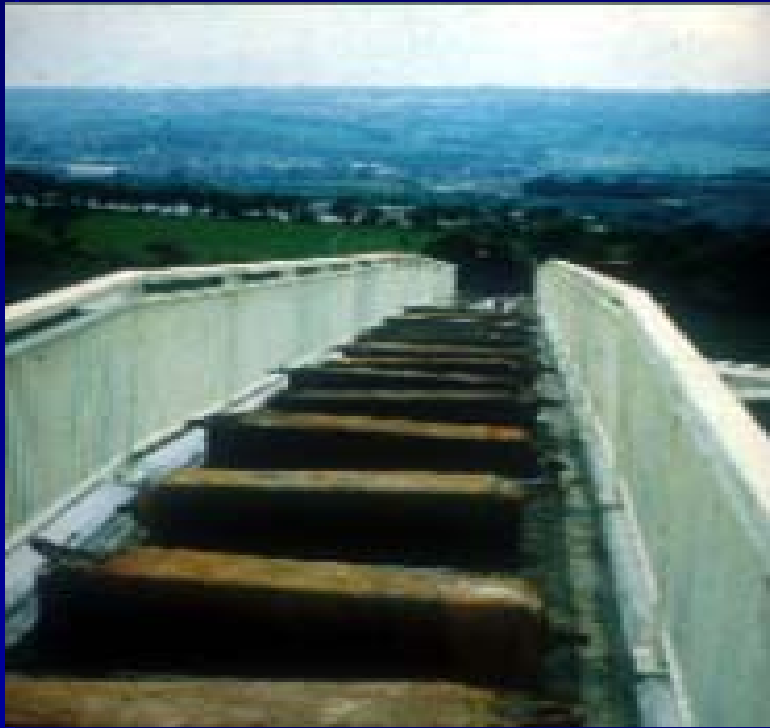
Load test

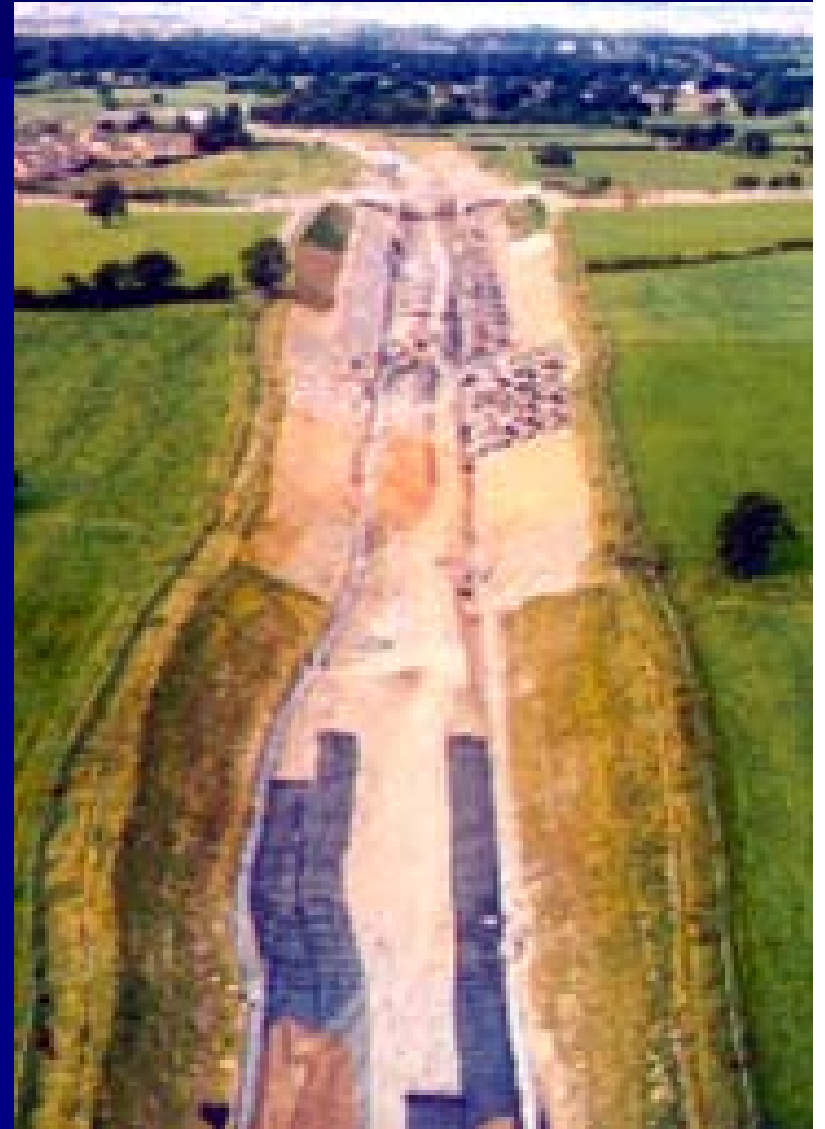
Excavation towards old workings
(construction in cutting)

Excavation towards old workings (construction in cutting)

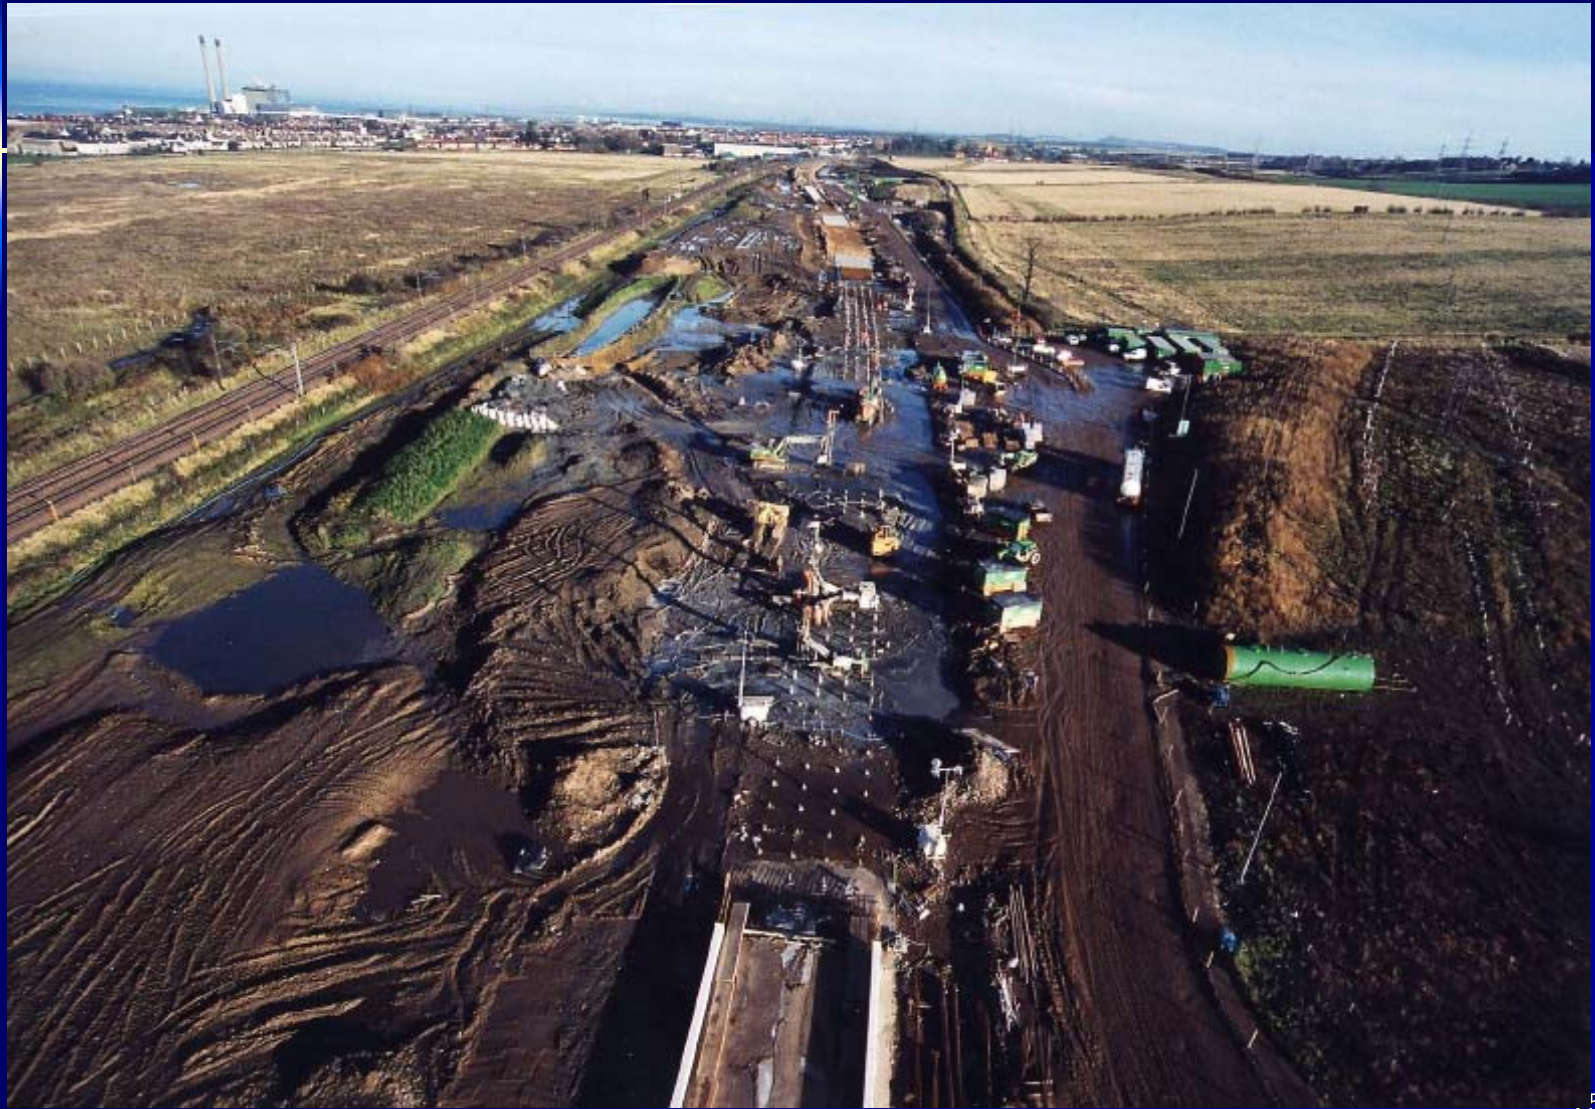
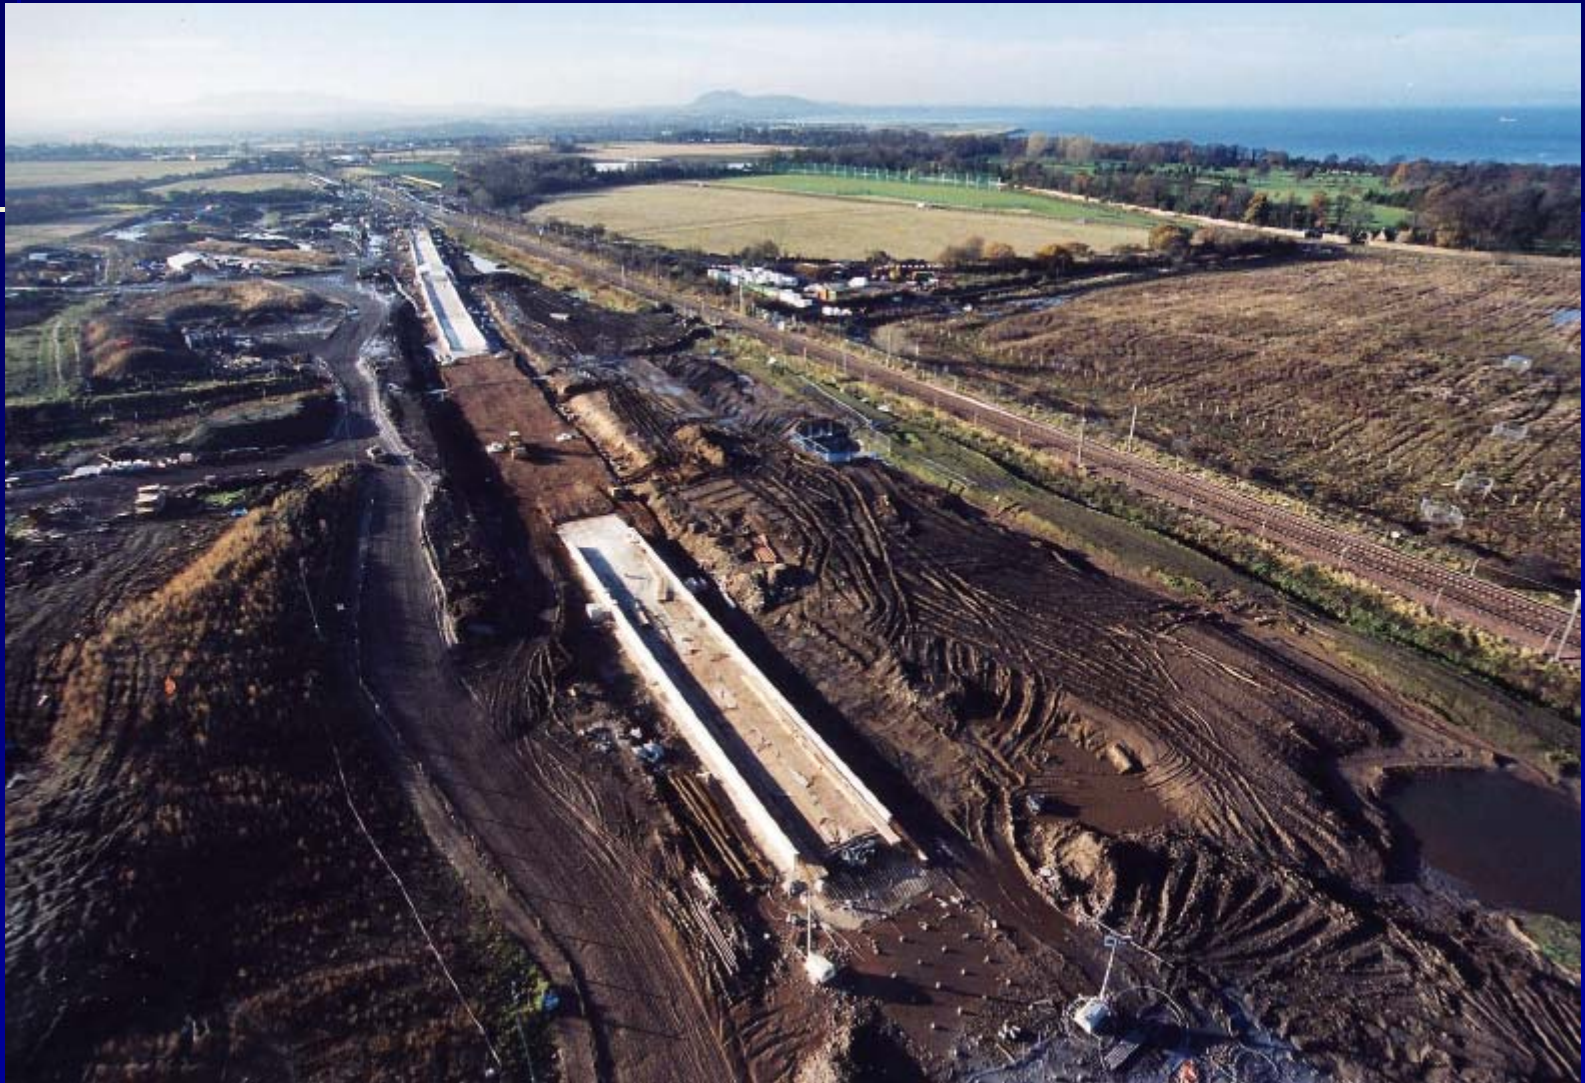
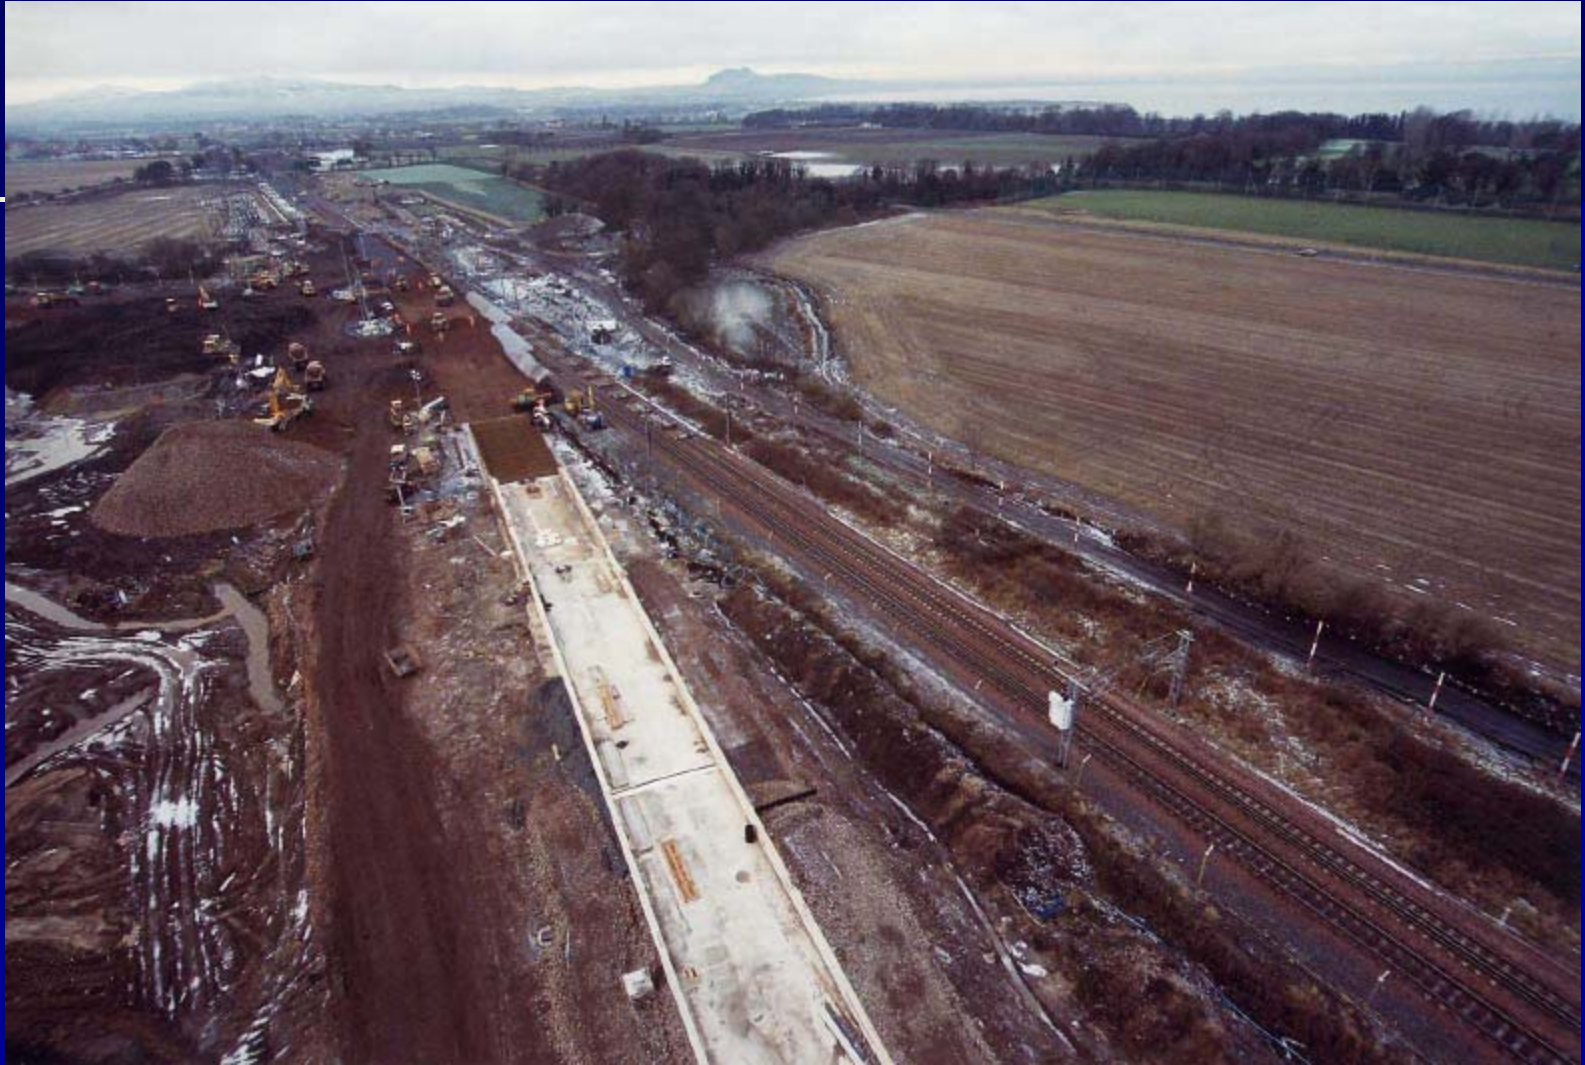
ECML

1. Temporary diversion of track, stabilize embankment and reinstate on original line
2. Permanent diversion of track
3. Repair by Grouting of voids and construction of concrete raft supported on piles passing below coal seams (Walk away solution)
4. Use high strength geotextiles to reinforce the embankment and provide permanent monitoring

Options 2 and 3 were selected

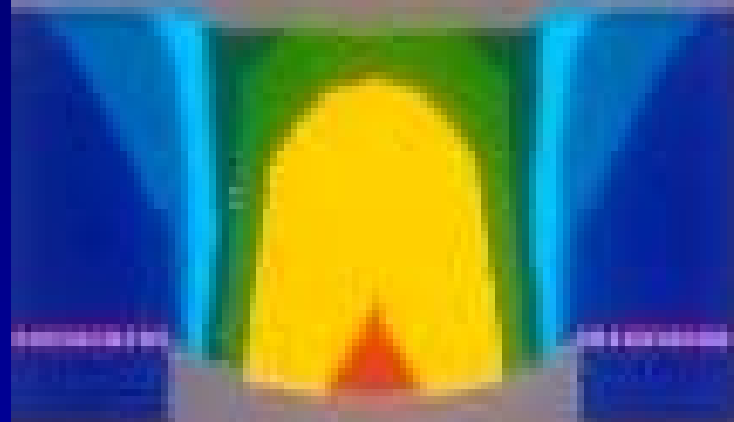
Effect of Reinforcement Stiffness

Rock foundation, $d = 4\text{m}$, $H = 4\text{m}$

Reinforcement stiffness
 $= 2,000\text{kN/m}$

$\Delta_x/\Delta_y = 3.7\%$

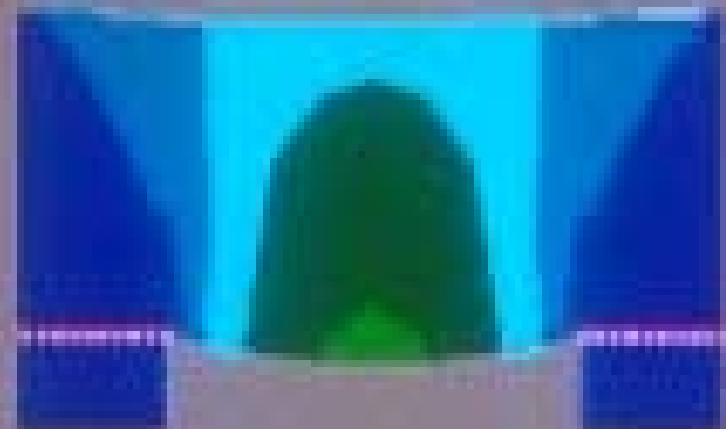
Reinforcement stiffness
 $= 12,000\text{kN/m}$

$\Delta_x/\Delta_y = 2.0\%$

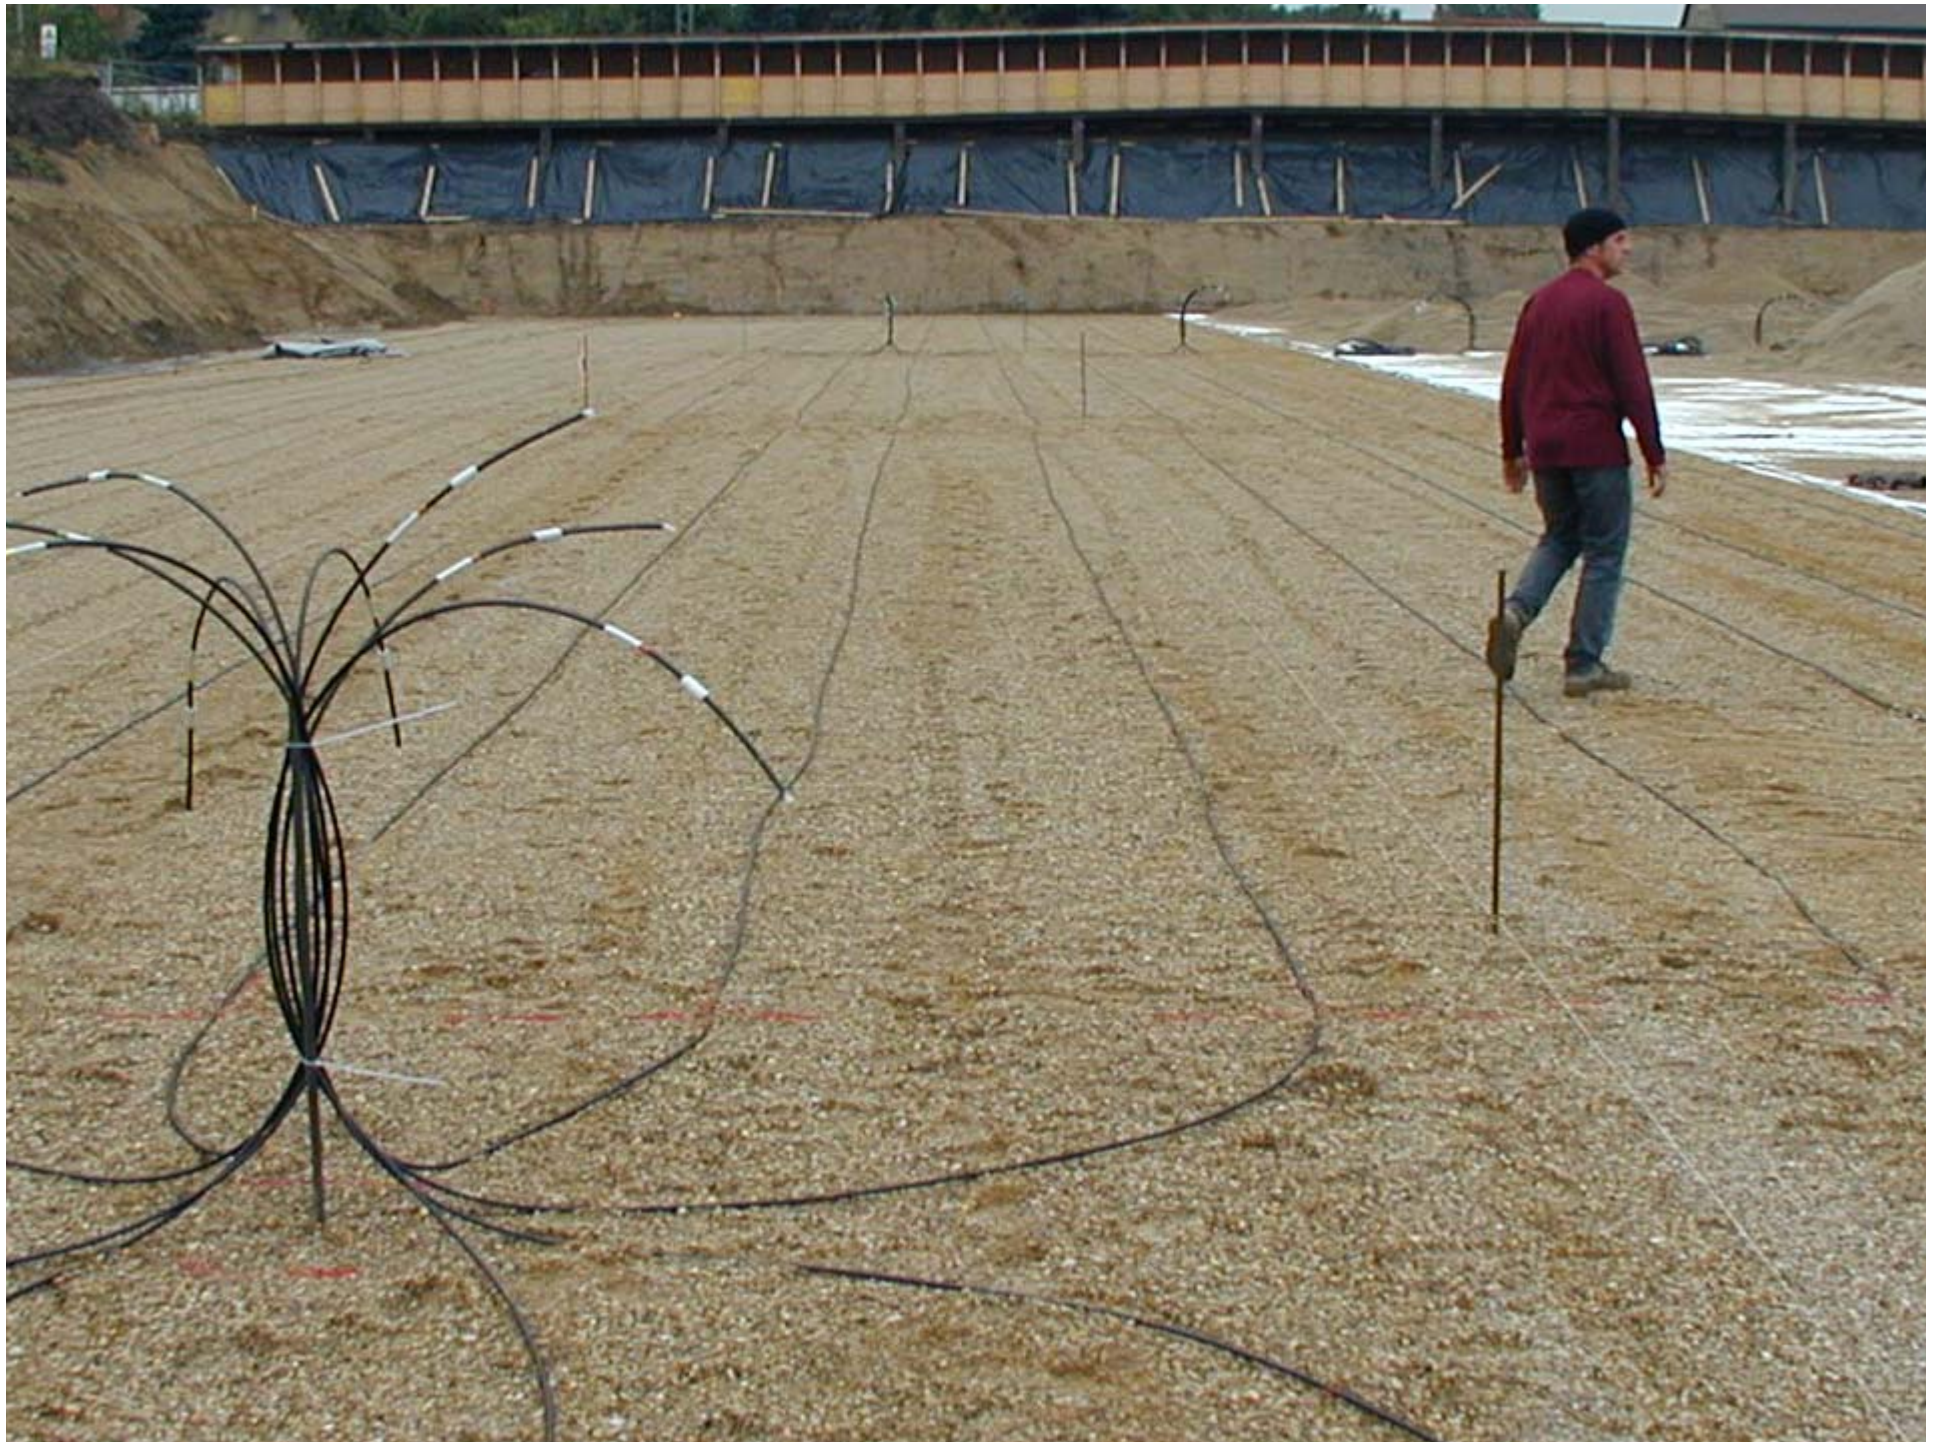
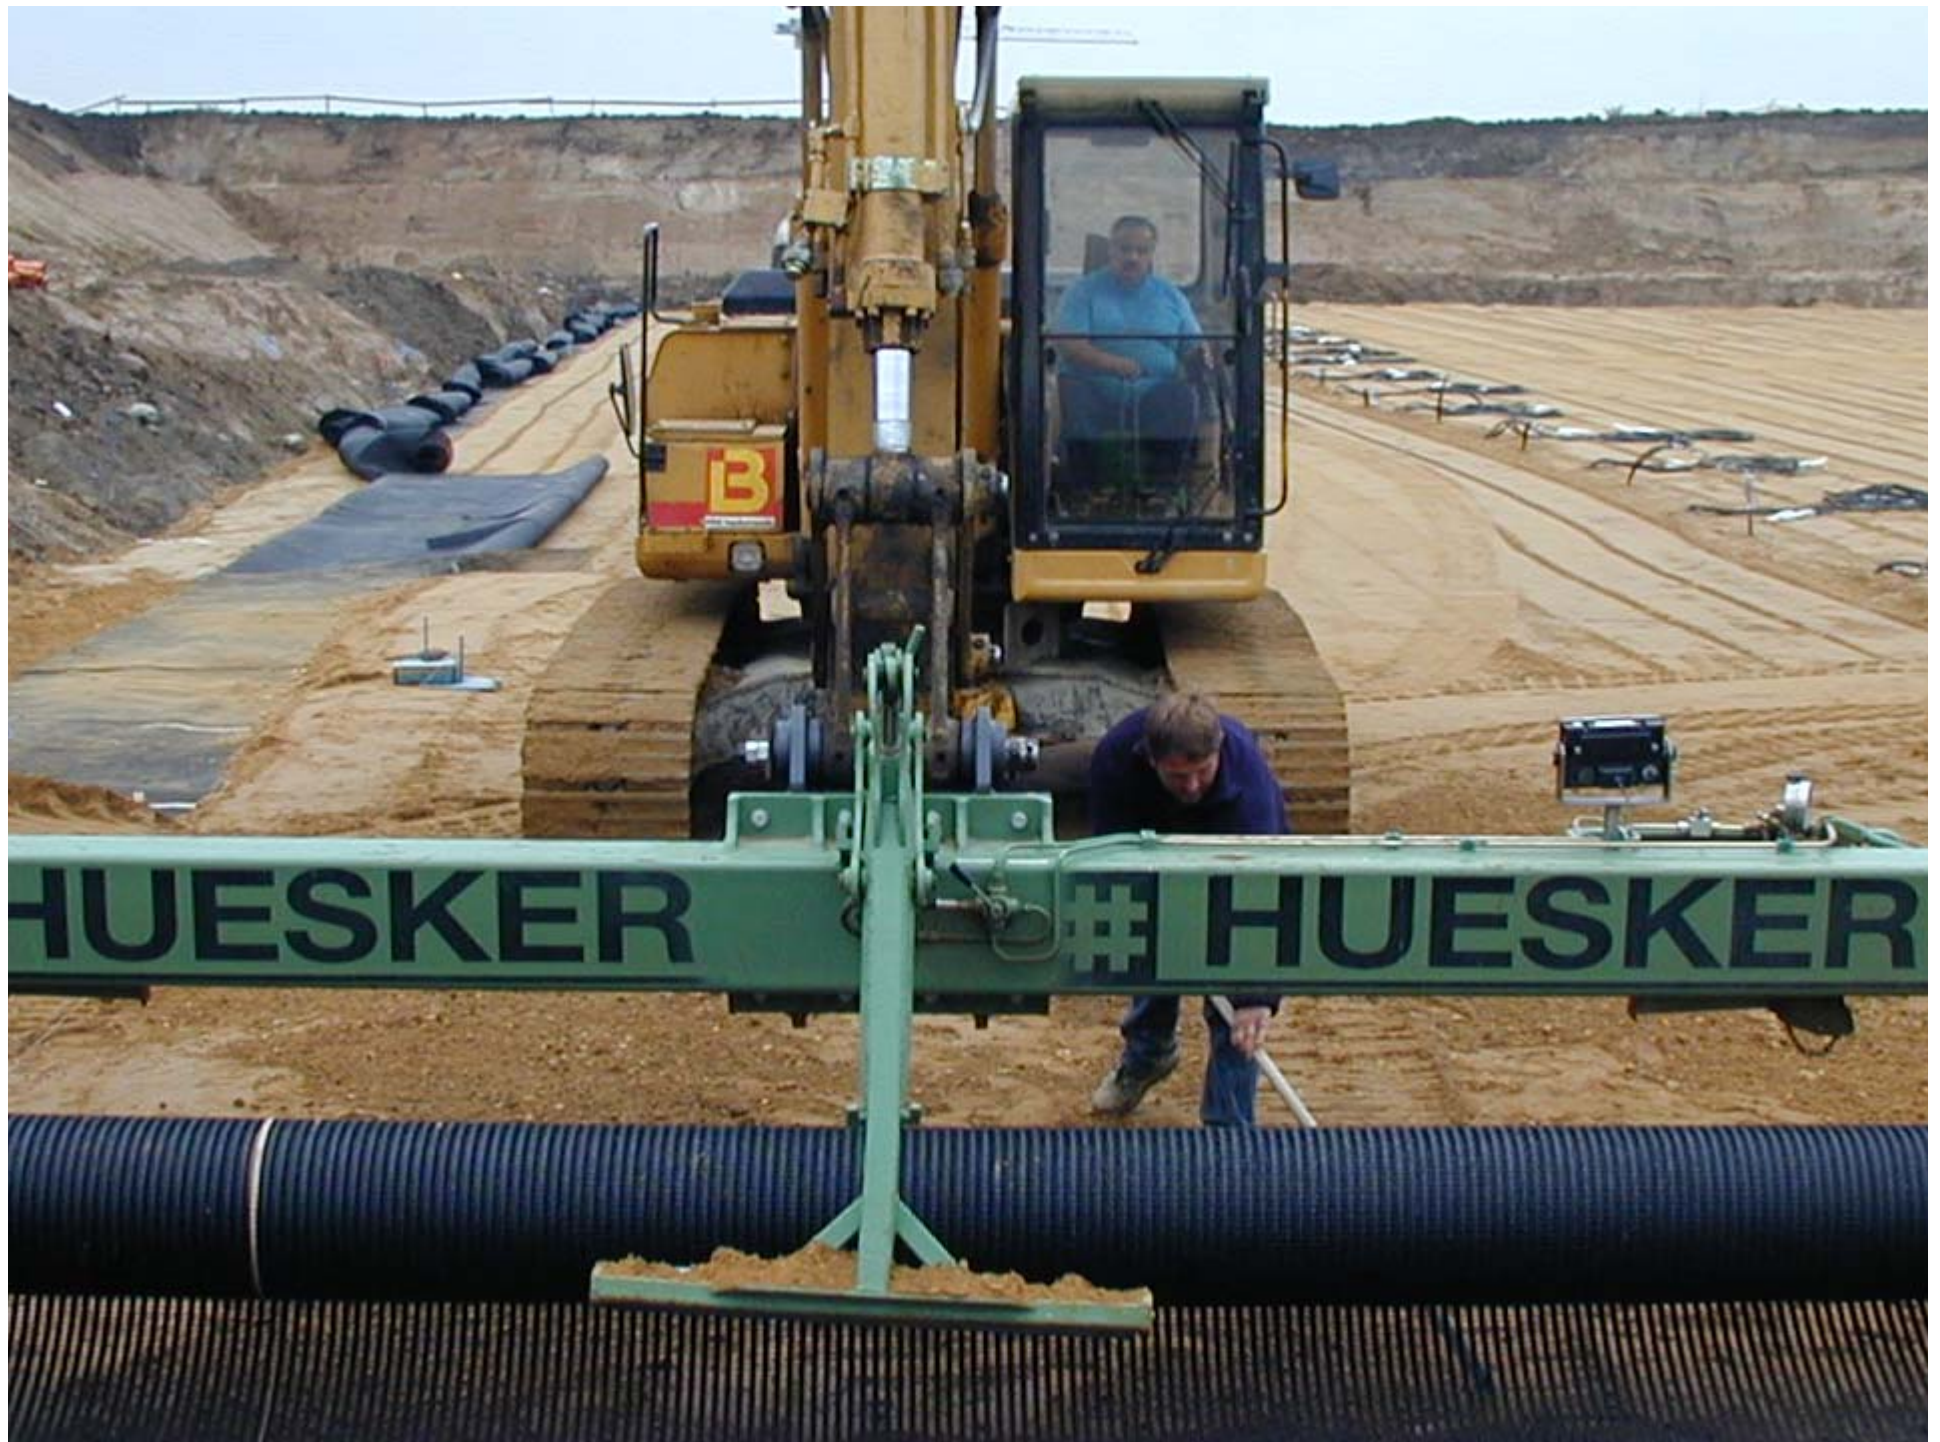
Groeblers Germany

Lage der Gülerzugssponge Nord
nach Koordinatenliste der Fa.
Ingenieurbüro Vössing,
erhalten am 14.12.99

Bewehrte Erde

Grenze der ehem.
Abbaueinwirkung

Groebers Solution

Requires **permanent** monitoring

Remedial work still needed

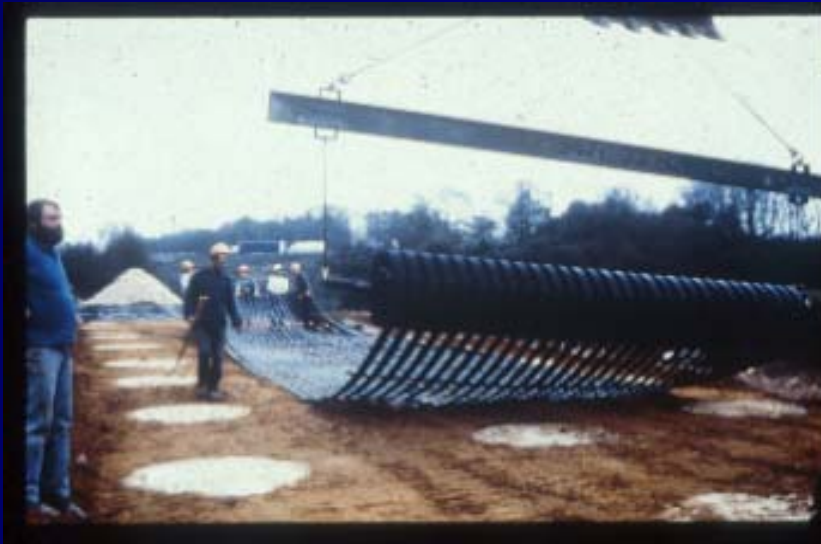
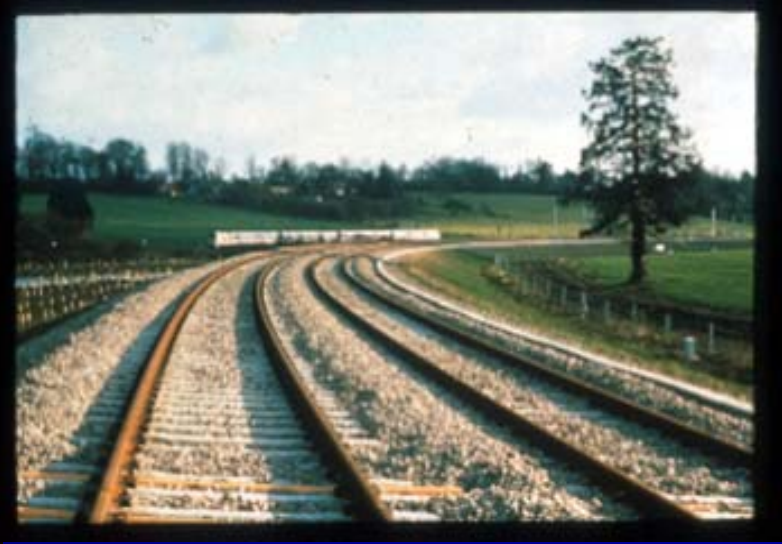
Geosynthetic Piled Embankment (as at Stansted, London)

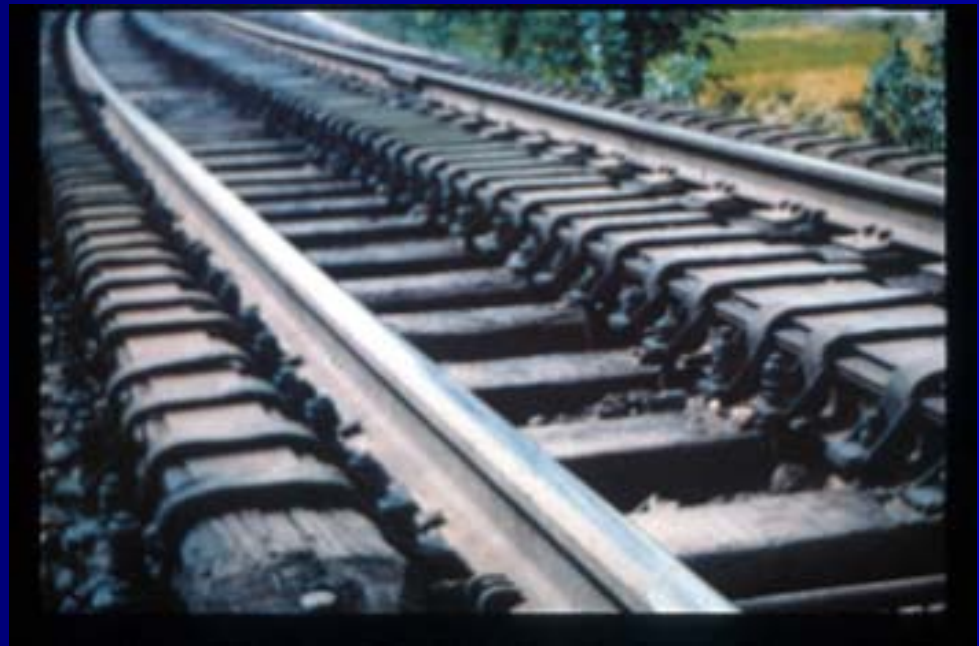
Modern form of "Logging"

A modern form of “logging” may be a solution
